Manhole Inspection Summary

Manhole # S35II_009MH

Insp Date: **3/13/07 10:32 AM**

Location Address: **1718 HUNTER ST**

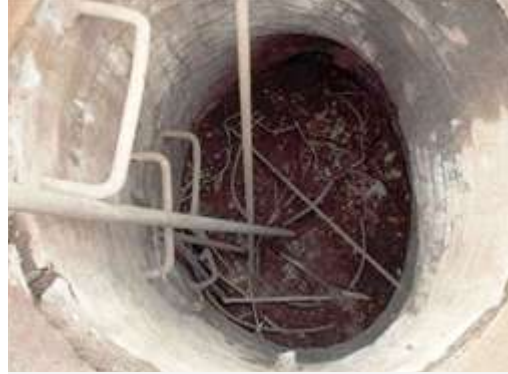
Top View

Channel debris.

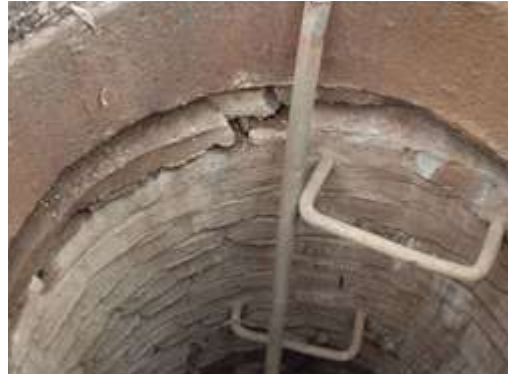
Defect

Frame leaks. Adjustment deterioration, loose brick and infiltration. Barrel infiltration - other side.

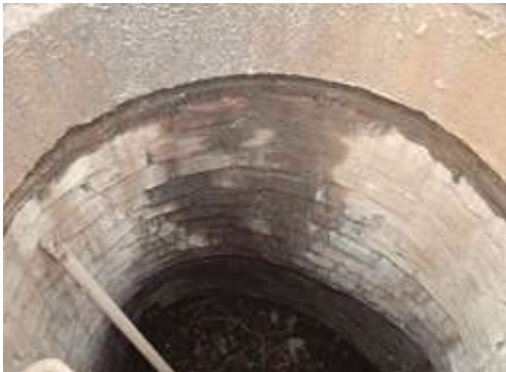
Defect

Frame leaks. Adjustment deterioration and infiltration. Barrel infiltration.

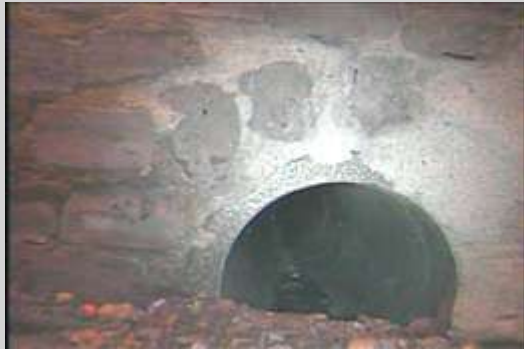
8 in. Circular Gravity Sewer
Pipe Out @ 12 O'Clock

Deposits: ☐ None ☒ **Mud** ☐ Sludge ☒ **Debris** ☐ Grease

Silt Depth: **1** (in.) Deposits Extent: **Light**
